Physical Processes & Geologic Hazards On The Oregon Coast

PHYSICAL PROCESSES AND GEOLOGIC HAZARDS
ON THE OREGON COAST

Paul D. Komar, PhD

May, 1979

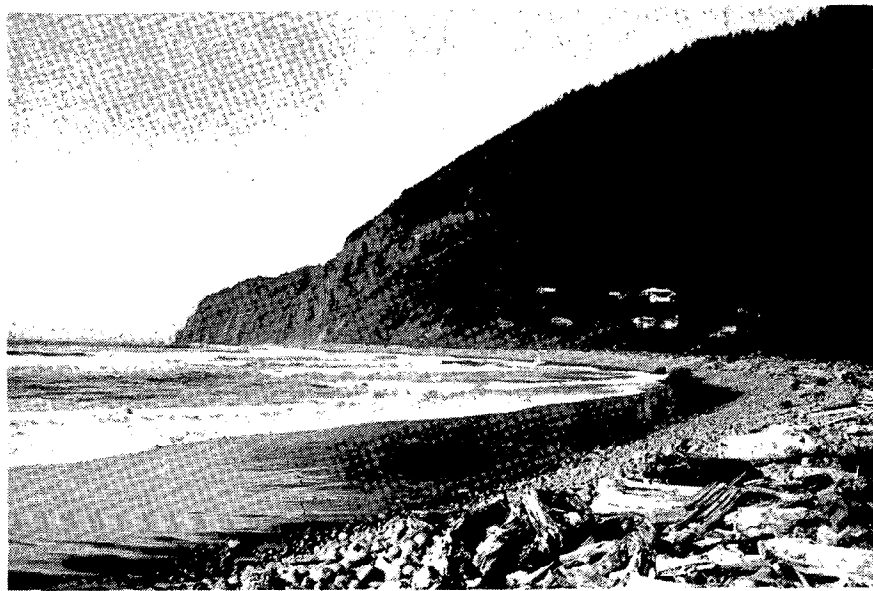
Figure 3. The beach at Neakahnie Beach with a steep cobble storm ridge of large rocks derived from the nearby basalt headland, backing an otherwise sandy beach. The cobble ridge offers protection to the coastal property.

Small pocket beaches in headland areas usually consist of basalt pebbles and cobbles (4 to 250 mm), the wave energy being too great for sand to remain on the beach. Continuing the trend of increasing beach slope with increasing grain size, these cobble beaches reach slopes of 5 to 25 degrees. Basaltic cobbles and pebbles are also found as a steep storm ridge along the flanks of headlands, backing the otherwise sandy beach (Figure 3). Such cobble ridges form a natural protective barrier from wave attack, important to such areas as Neakahnie Beach south of Cape Falcon (Figure 3).

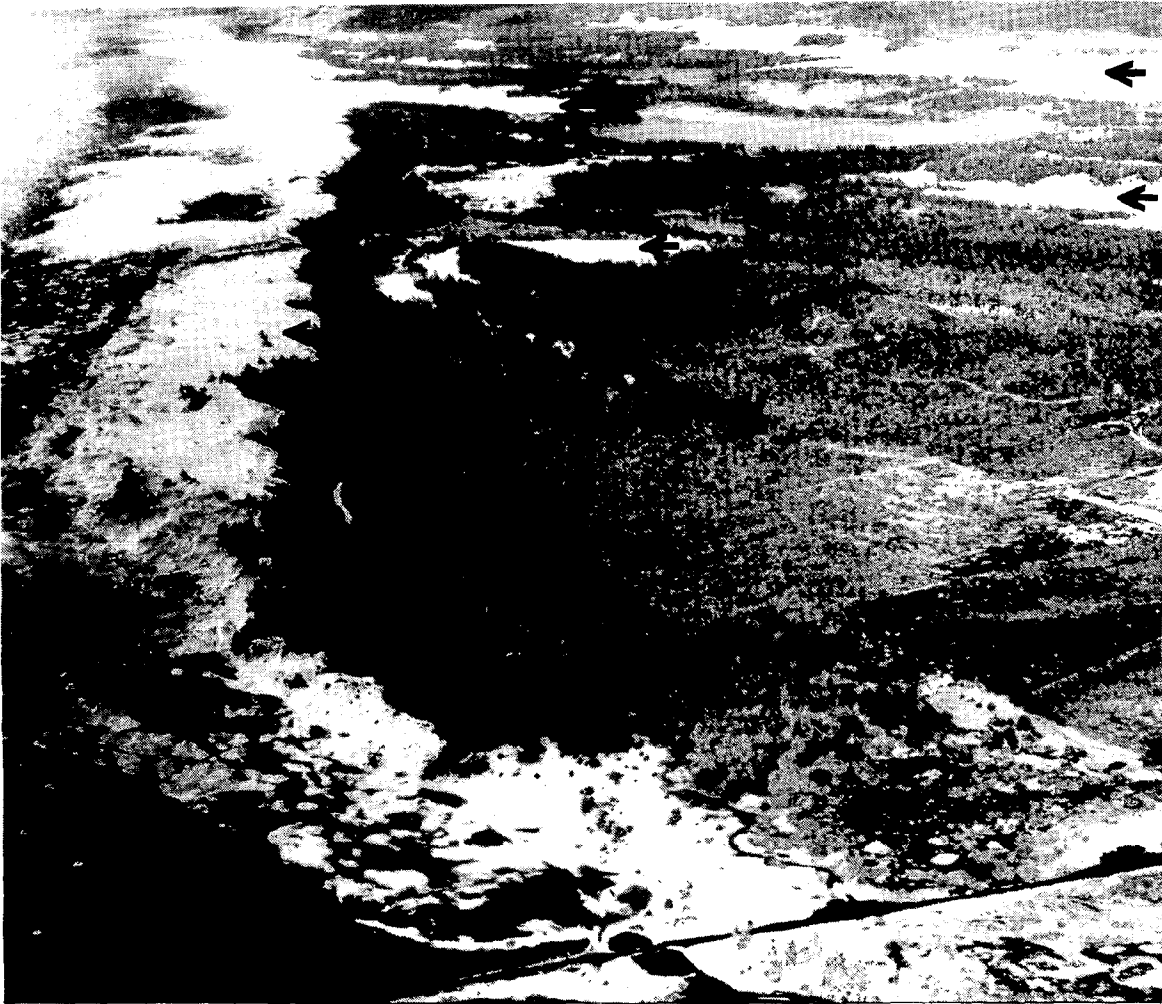
Figure 6. The active dune field of the Coos Bay dune sheet which stretches for some 55 miles along the mid-Oregon coast (photo courtesy of U.S. Army Corps of Engineers, Portland District).

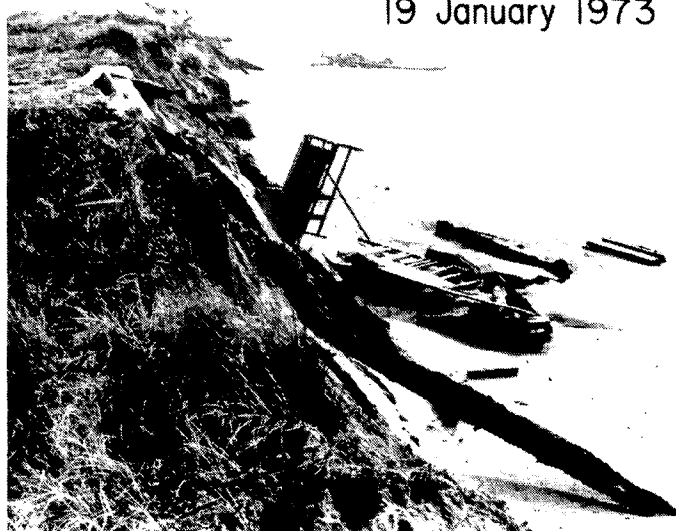
28 December 1972

19 January 1973

Figure 23. Destruction of house under construction on Siletz Spit due to the rapid wave erosion of the foredunes upon which the house was being built (from Komar and Rea, 1976).

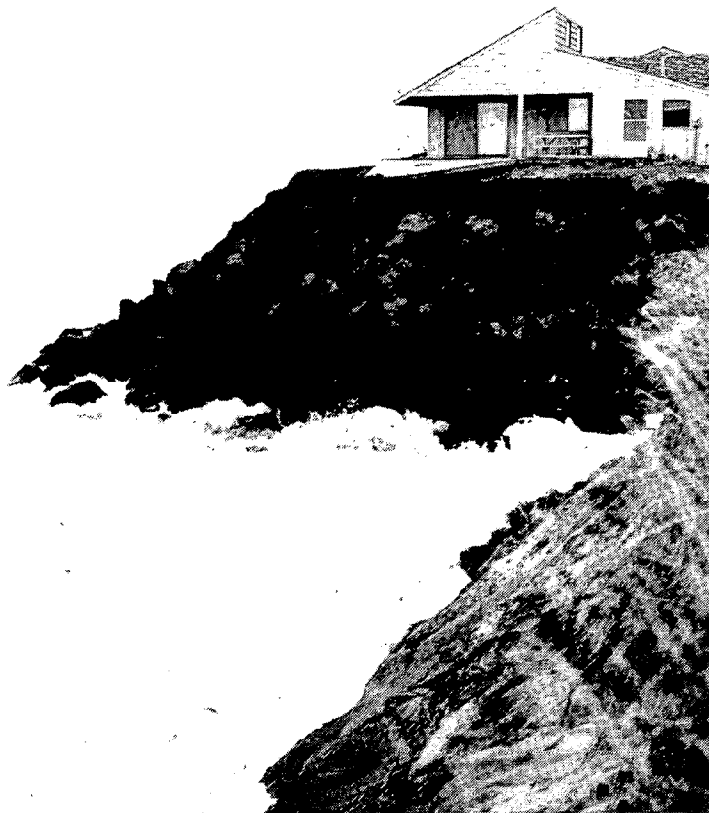
Figure 24. House left on a promontory of riprap on Siletz Spit as adjacent unprotected empty lots continued to erode (Photo by P. D. Komar, 23 January 1973).

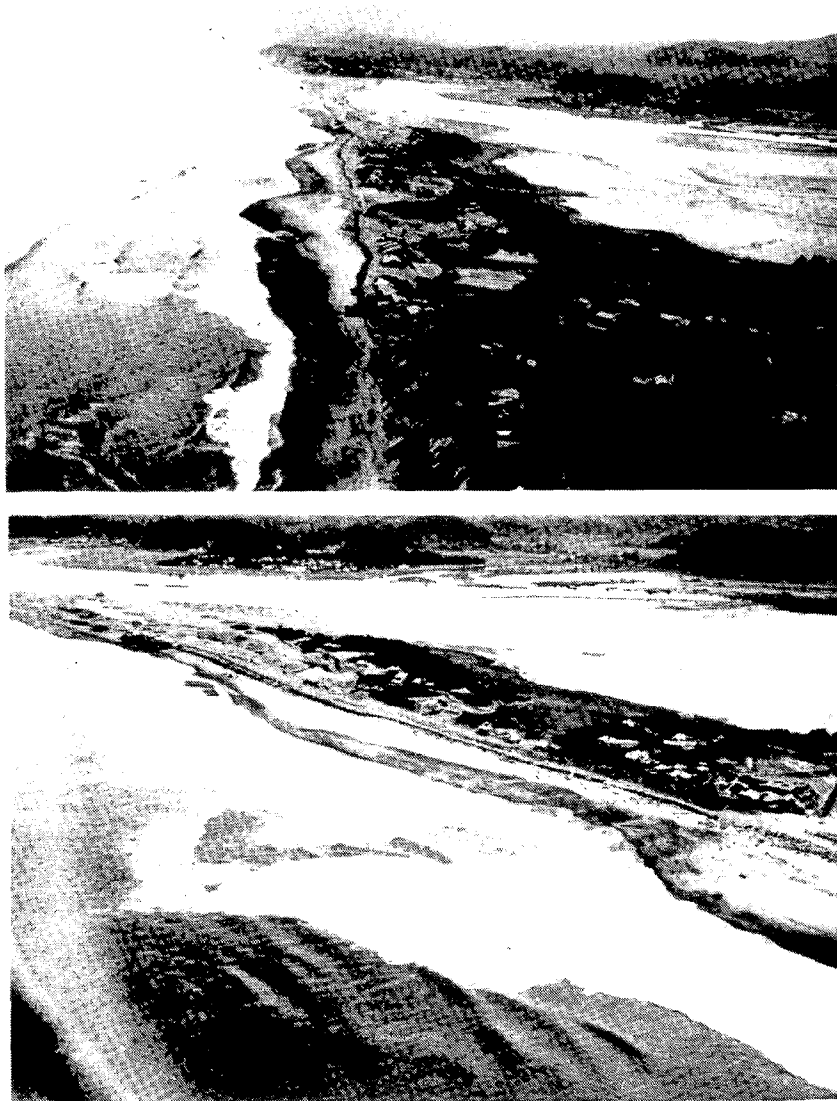
Figure 26. Embayments cut out of the beach and into the foredunes on Siletz Spit leading to property losses during December 1972 and January 1973, produced by seaward flowing rip currents (from Komar and Rea, 1976).

Thus the positioning of the rip currents during the winter governs the locations of maximum beach and foredune erosion. This usually changes from one winter to the next so the areas of erosion are not always the same. At present we are unable to predict where the rip currents will form. But once it is seen where they are positioned we can anticipate that these could be potential erosion sites. During some winters they remain relatively fixed in position and so are able to hollow out large embayments; such conditions are most conducive to major erosion. During other winters the rip currents migrate somewhat north-south, probably when waves arrive obliquely to the coastline, and do not form as large embayments; consequently the potential for erosion is smaller.

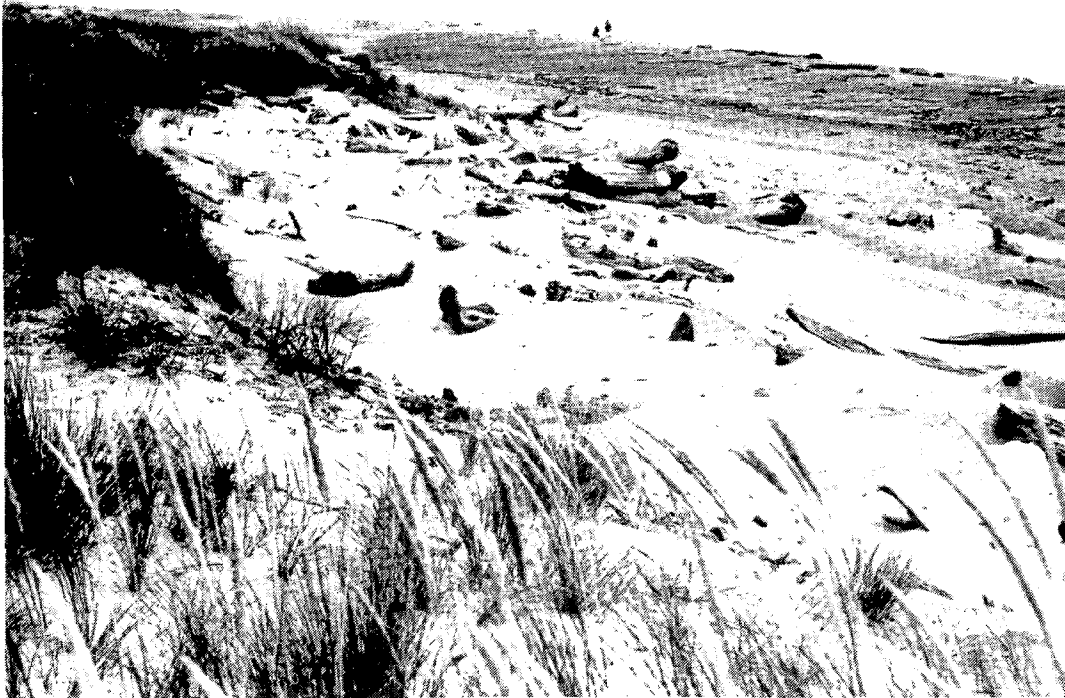
Figure 27. Drift logs washed into an embayment cut by a rip current on Siletz Spit, now actively trapping wind-blown sands and beginning to reform the foredunes (from Rea and Komar, 1975).

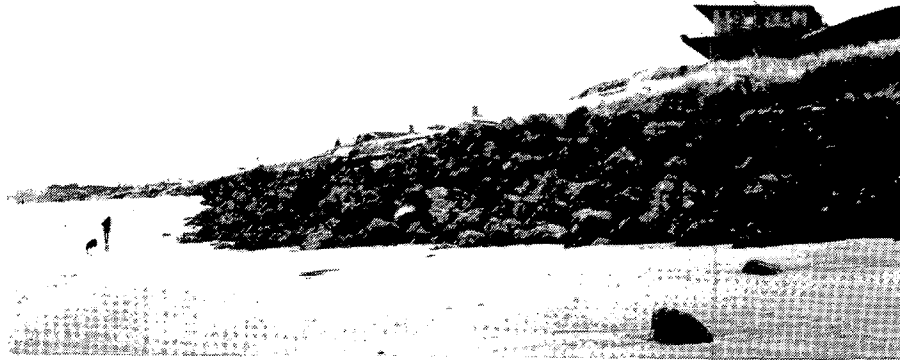
Figure 28. Large piles of riprap employed on Siletz Spit to protect the homes built on the foredunes.

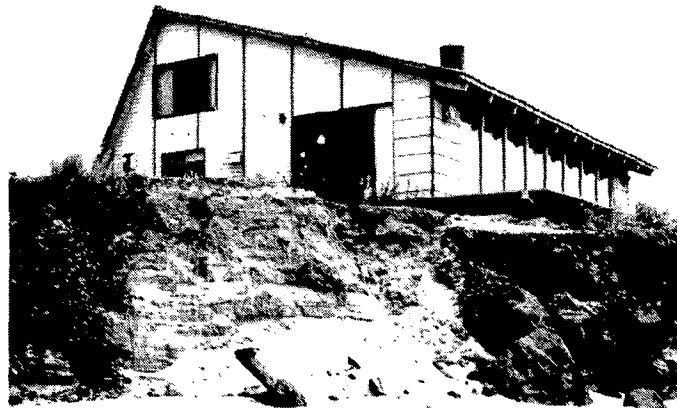
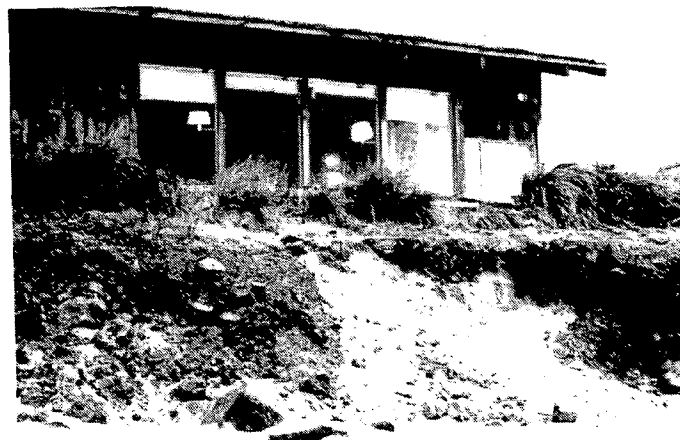
Figure 29. Erosion of riprap on Siletz Spit by a series of storms, exposing the dune sands to wave attack (from Rea and Komar, 1975).

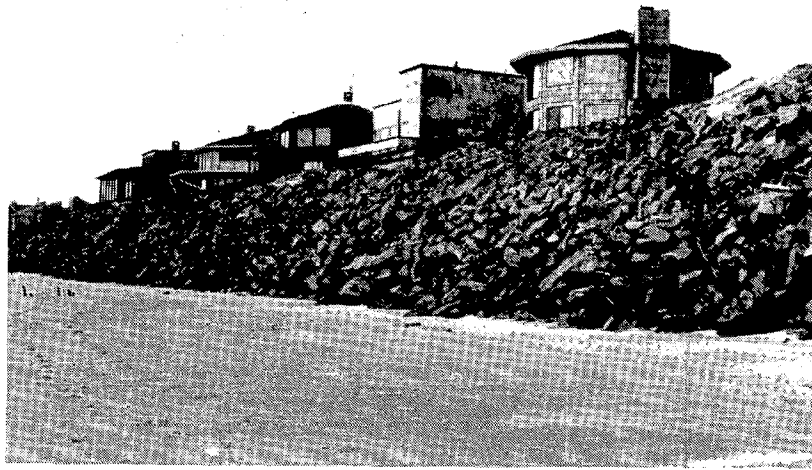
Figure 31. Homes to the south of Cape Kiwanda protected by riprap placed due to the erosion of the foredunes upon which they were being constructed (from Komar, 1978).

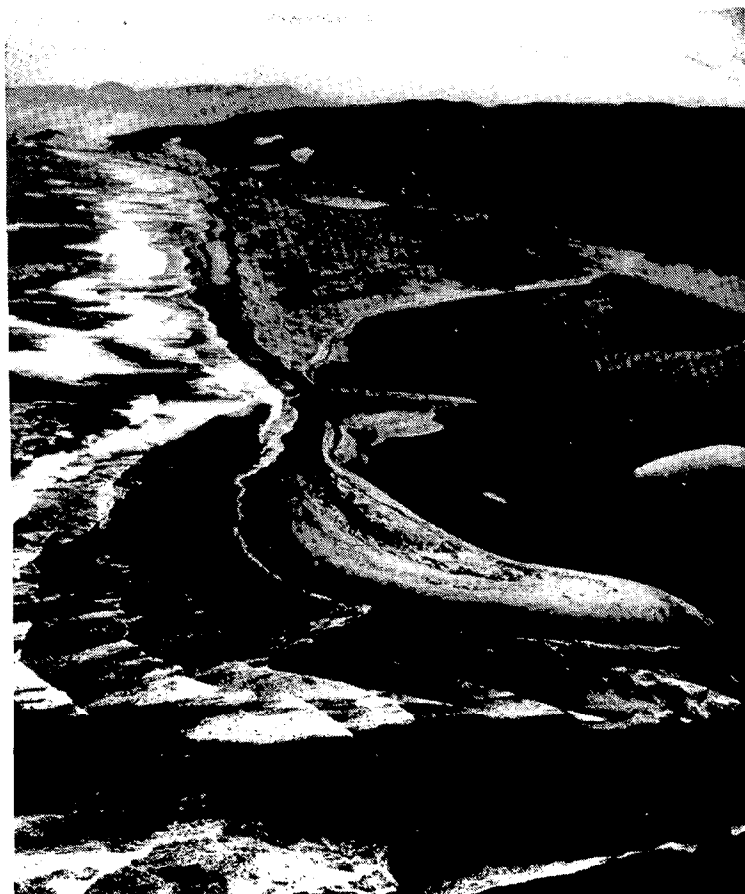
Figure 32. The breach in Nestucca Spit produced by a combination of unusually high storm waves and high Spring tides in early February 1978 (State of Oregon, Highway Department photo).

time of high Spring tides on 5 February 1978, the resulting erosion broke through the spit near its southern end (Figure 32). This is the only known occurrence of the natural breaching of a sand spit on the west coast of the United States (the breaching of Bayocean Spit, discussed above, was not natural in that the ultimate cause was the construction of jetties). Fortunately, the breached site at Nestucca Spit was well away from any developments and so threatened no dwellings. However, it did demonstrate the fragile nature of sand spits and their general unsuitability for development.

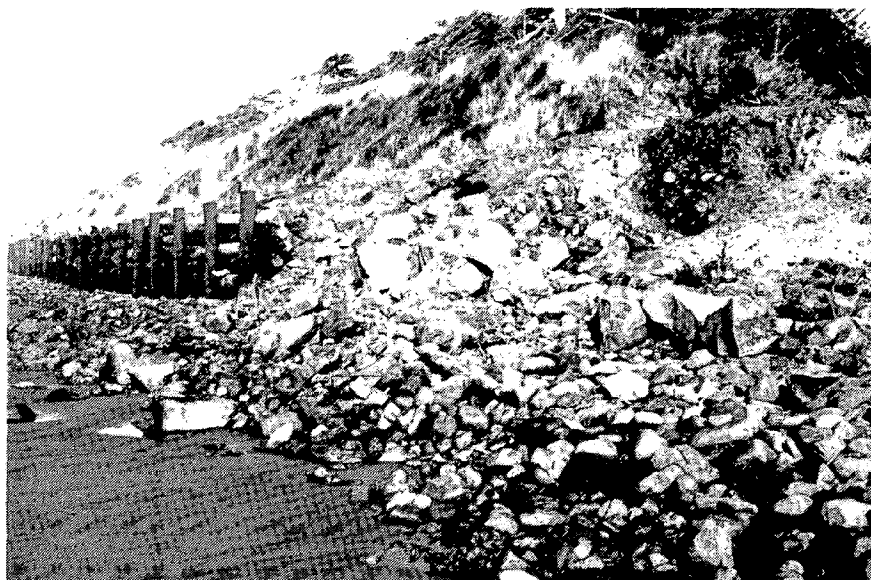
Figure 33. The wood piling bulkhead built on Netarts Spit to stop wave attack of the dunes.

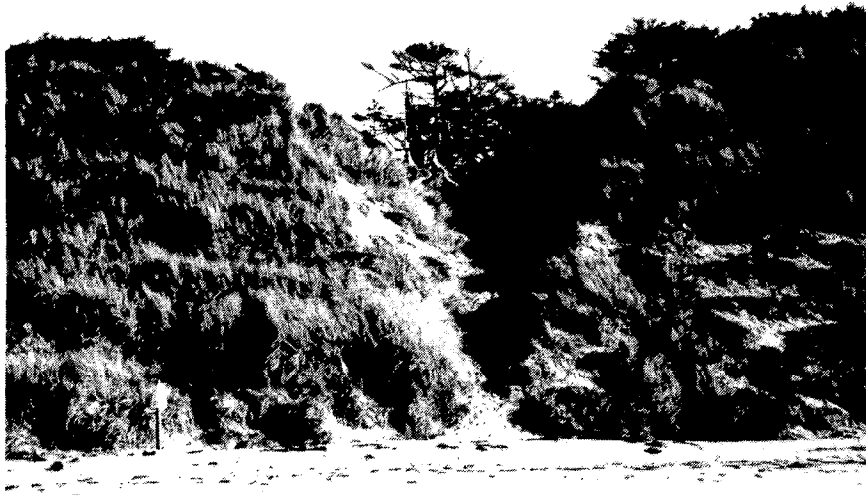
Figure 34. Degradation of the dunes on Netarts Spit due to visitors cutting a path from the beach to the state park.

The dune bluff facing the ocean is vegetated and also testifies to the fact that little or no erosion has occurred in recent years. At times the waves do reach the base of the slope, making a slight notch into the dunes, but this has been minor. It would probably take a very unusual combination of storm waves, high tides and a storm surge to cause appreciable erosion on the spit. At present, the chief problem is due to visitors cutting paths through the dune vegetation (Figure 34) which may lead to wind erosion of the dunes.

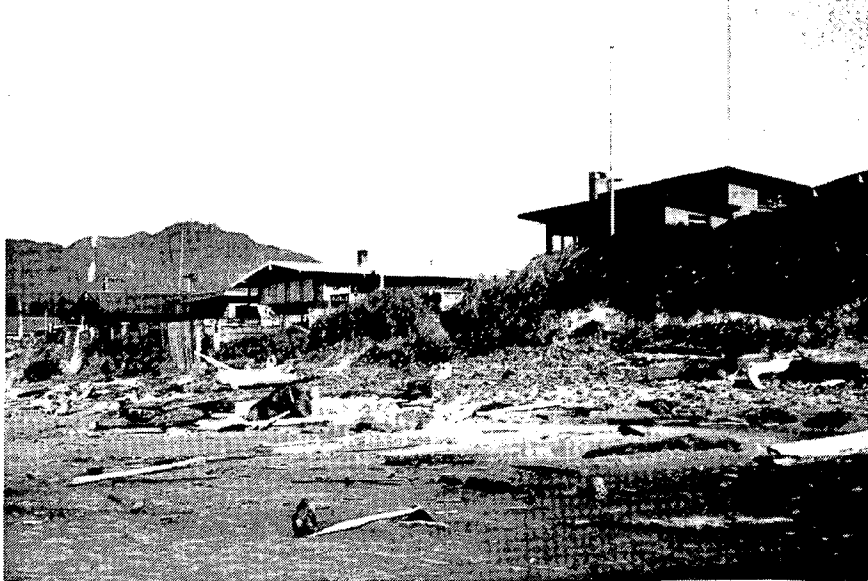
Figure 35. Long-term progressive erosion in Manzanita, now nearing some of the homes.

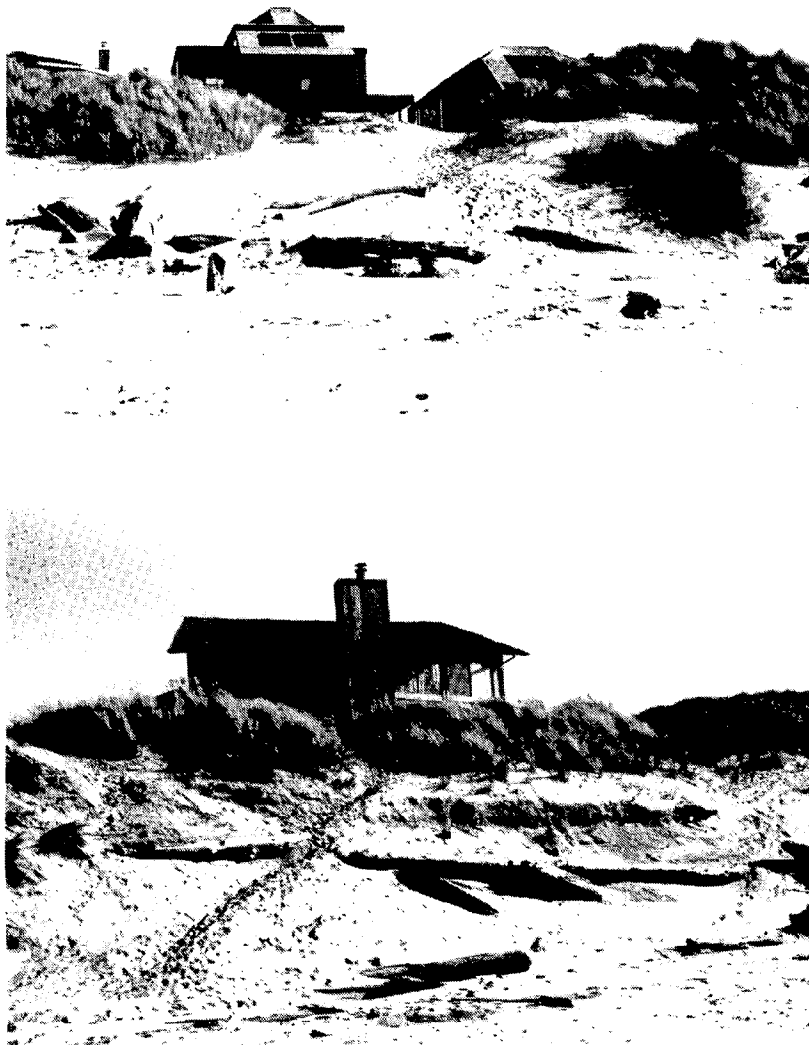
Figure 36. Homes built on Nehalem Spit in an area of active foredunes susceptible both to ocean wave attack and wind erosion.

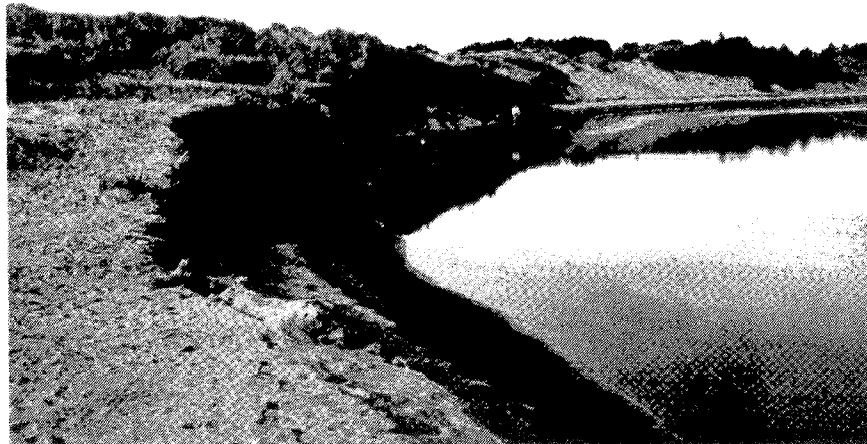
Figure 37. Bay-shore erosion at Gearhart, caused by the flow of the Neawanna Creek against the property.

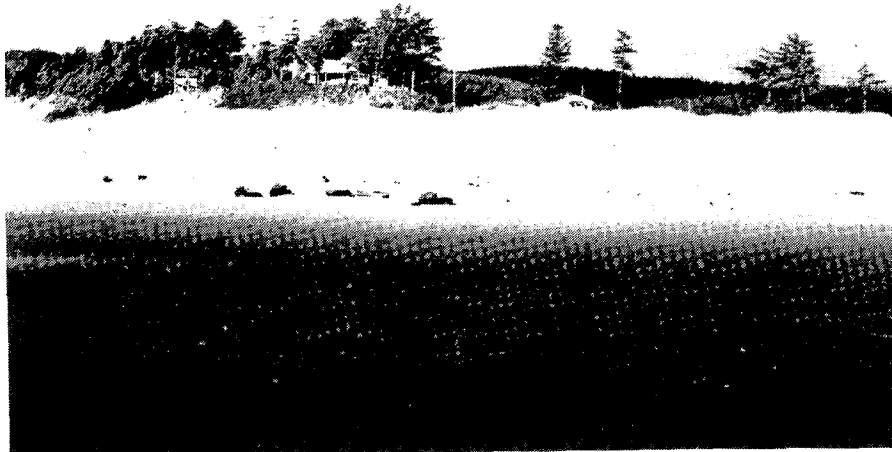
Figure 39. Foredunes at Breakers Point, Cannon Beach; backed by older, well-vegetated dunes into which waves at some time cut a near-vertical scarp.

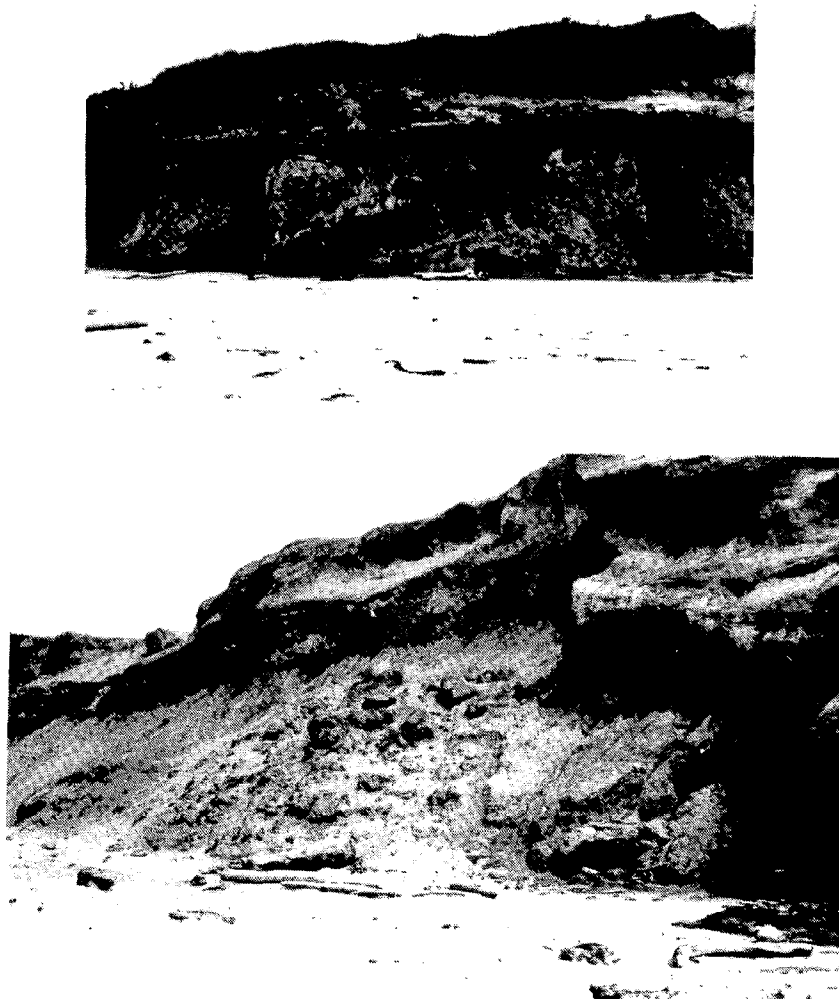
Figure 40. Typical sea cliffs of the Oregon coast formed by erosion of marine terraces. The upper photo shows a thin layer of Pleistocene terrace sands overlying older Tertiary mudstones with an apparent dip to the left. The lower photo, from the Lincoln City area, is a sea cliff composed entirely of terrace sandstones, and is seen to be more susceptible to erosion processes.

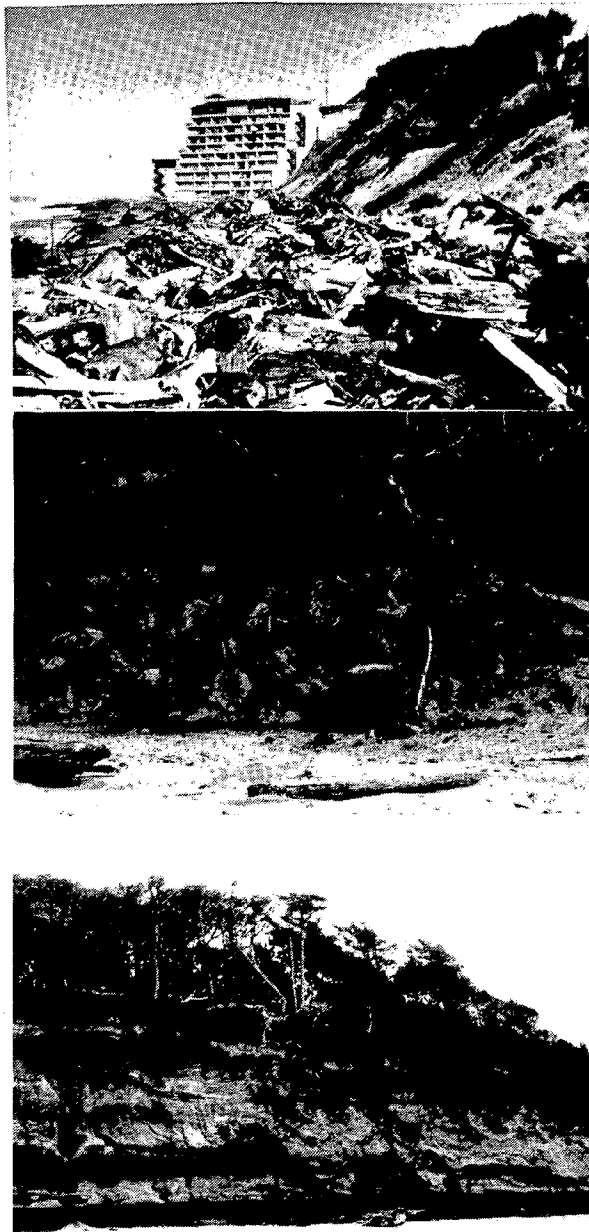
Figure 41. The extent of talus accumulation at the base of the sea cliff can give some indication of the frequency or recency of wave attack. The upper photo from Taft shows a considerable accumulation with the development of vegetation, indicating an extended period of time since wave erosion, in this case the logs possibly offering some protection (compare with Figure 42 of the same area after erosion during the winter of 1977-78). The middle photo from Gleneden Beach shows a sea cliff with a large talus accumulation but no vegetation, indicating no wave attack for perhaps 5 to 10 years. The lower photo is from the same area, the severe storms of the winter of 1977-78 having washed away all of the talus accumulation.

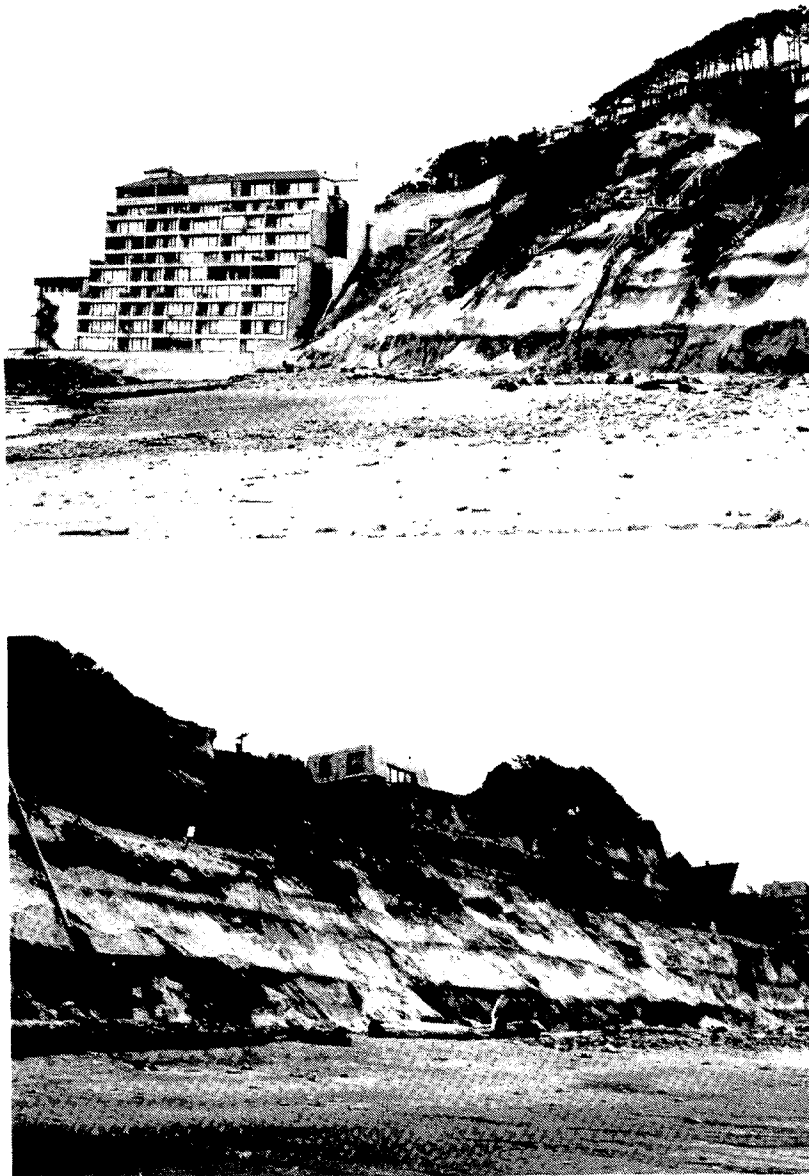
Figure 42. Sea cliff erosion at Taft during the winter of 1977-78. Compare with the first photo of Figure 41 of the same area, noting the loss of logs on the beach and the loss of the vegetated tallus slope.

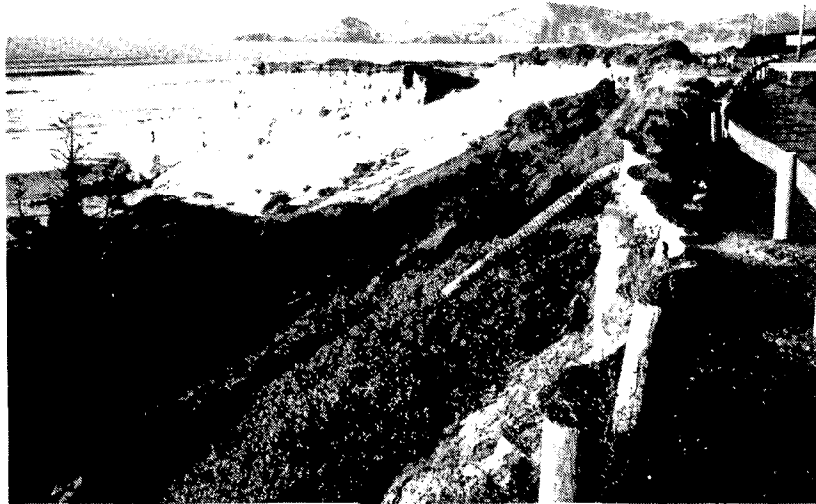
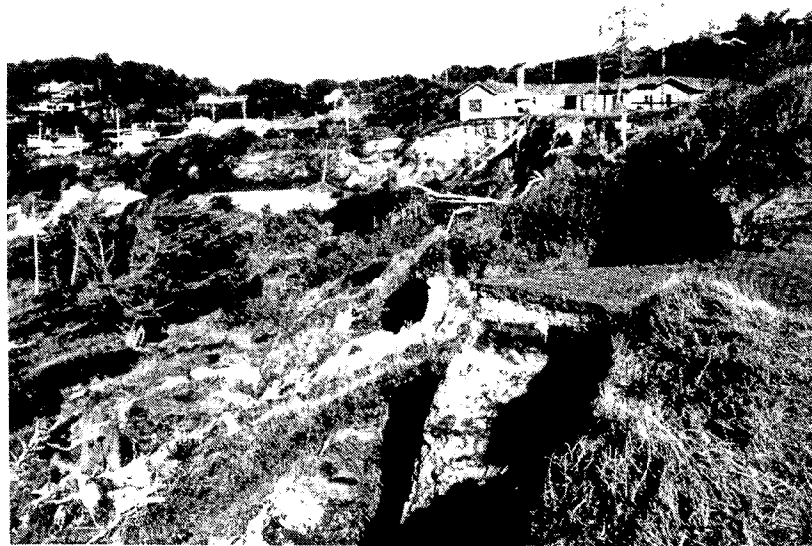
Figure 44. Large landslides in the Jumpoff Joe area of Newport.

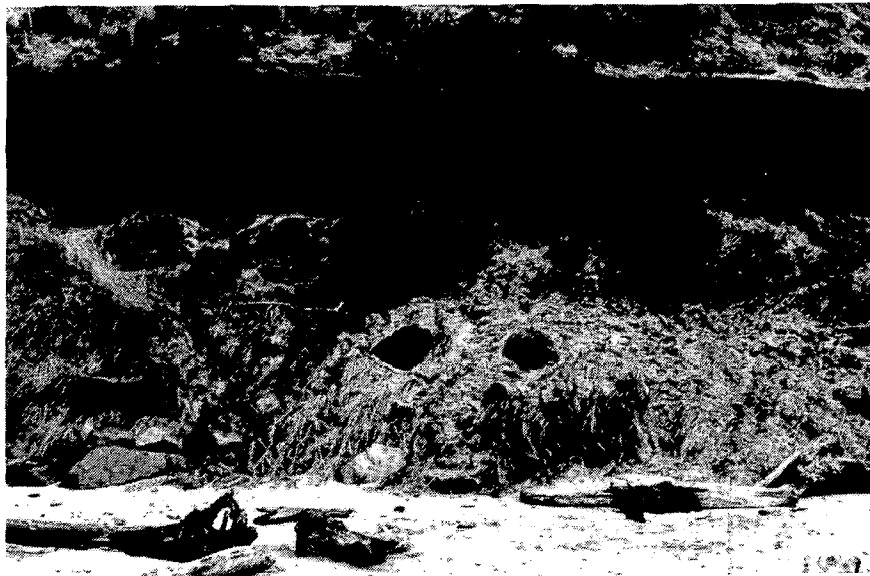
Figure 47. Graffiti carved into a sea cliff at Lincoln City, having a significant effect on the long-term cliff retreat rate.

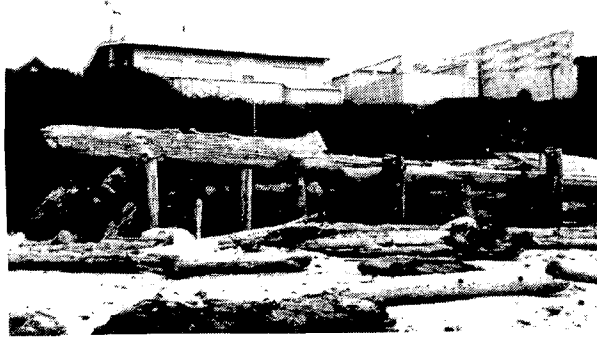
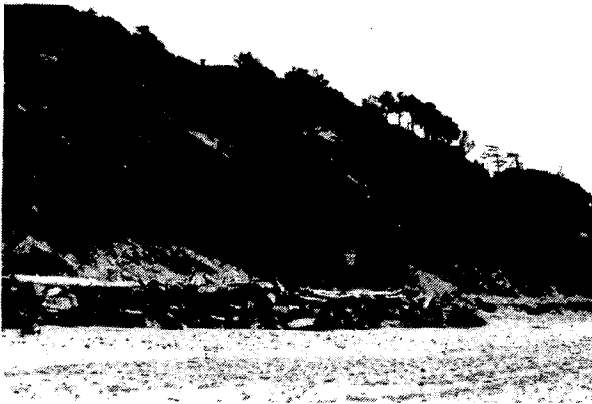
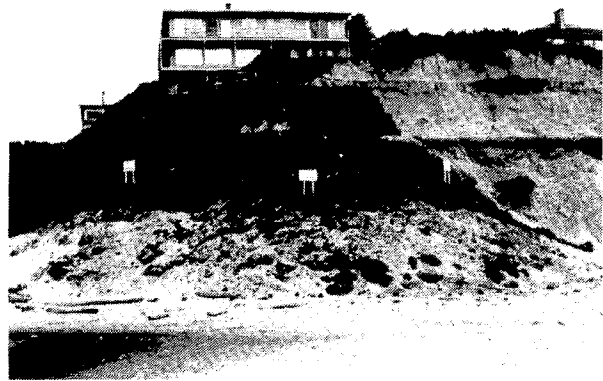
Figure 48. A variety of sea cliff protection approaches have been employed on the Oregon coast, mainly involving log sea walls, concrete sea walls and riprap.

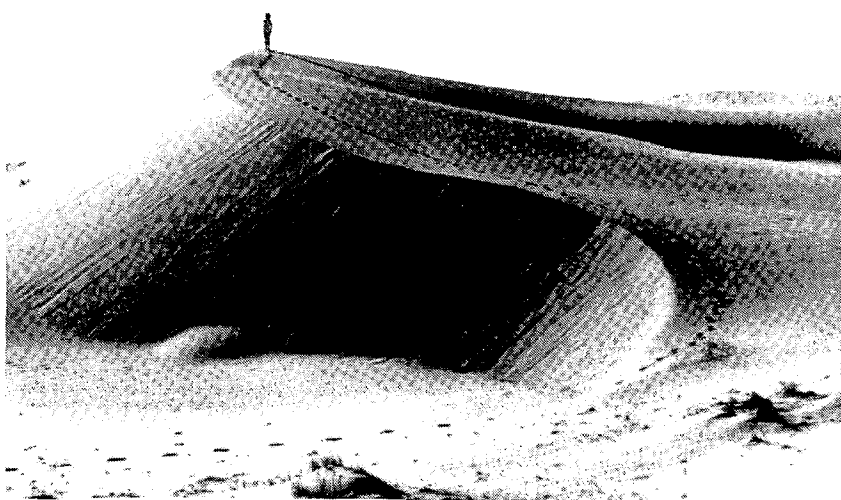
Figure 49. The two active dune types found on the Oregon coast, the transverse-ridge pattern and the oblique-ridge pattern, both now largely confined to the Coos Bay dune sheet. (Lower photo courtesy of Oregon Department of Transportation.)

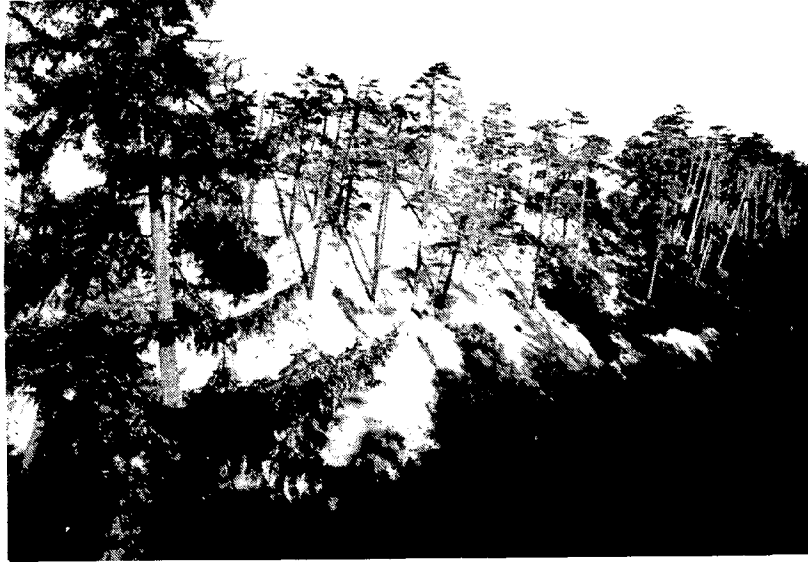
Figure 51. A precipitation ridge of the Coos Bay dune sheet migrating slowly landward, burying trees in its path. (Photo courtesy of Oregon Department of Geology and Mineral Industries.)
